Exhibit B - Asbestos Report

Project No.: IH-16-003

**RE: Report for a Limited Asbestos Inspection
of the Commercial Facility Located at
2415 Mullan Rd.
Missoula, MT 59808**

Report for Asbestos Inspection- Commercial Facility , 2415 Mullan Rd.

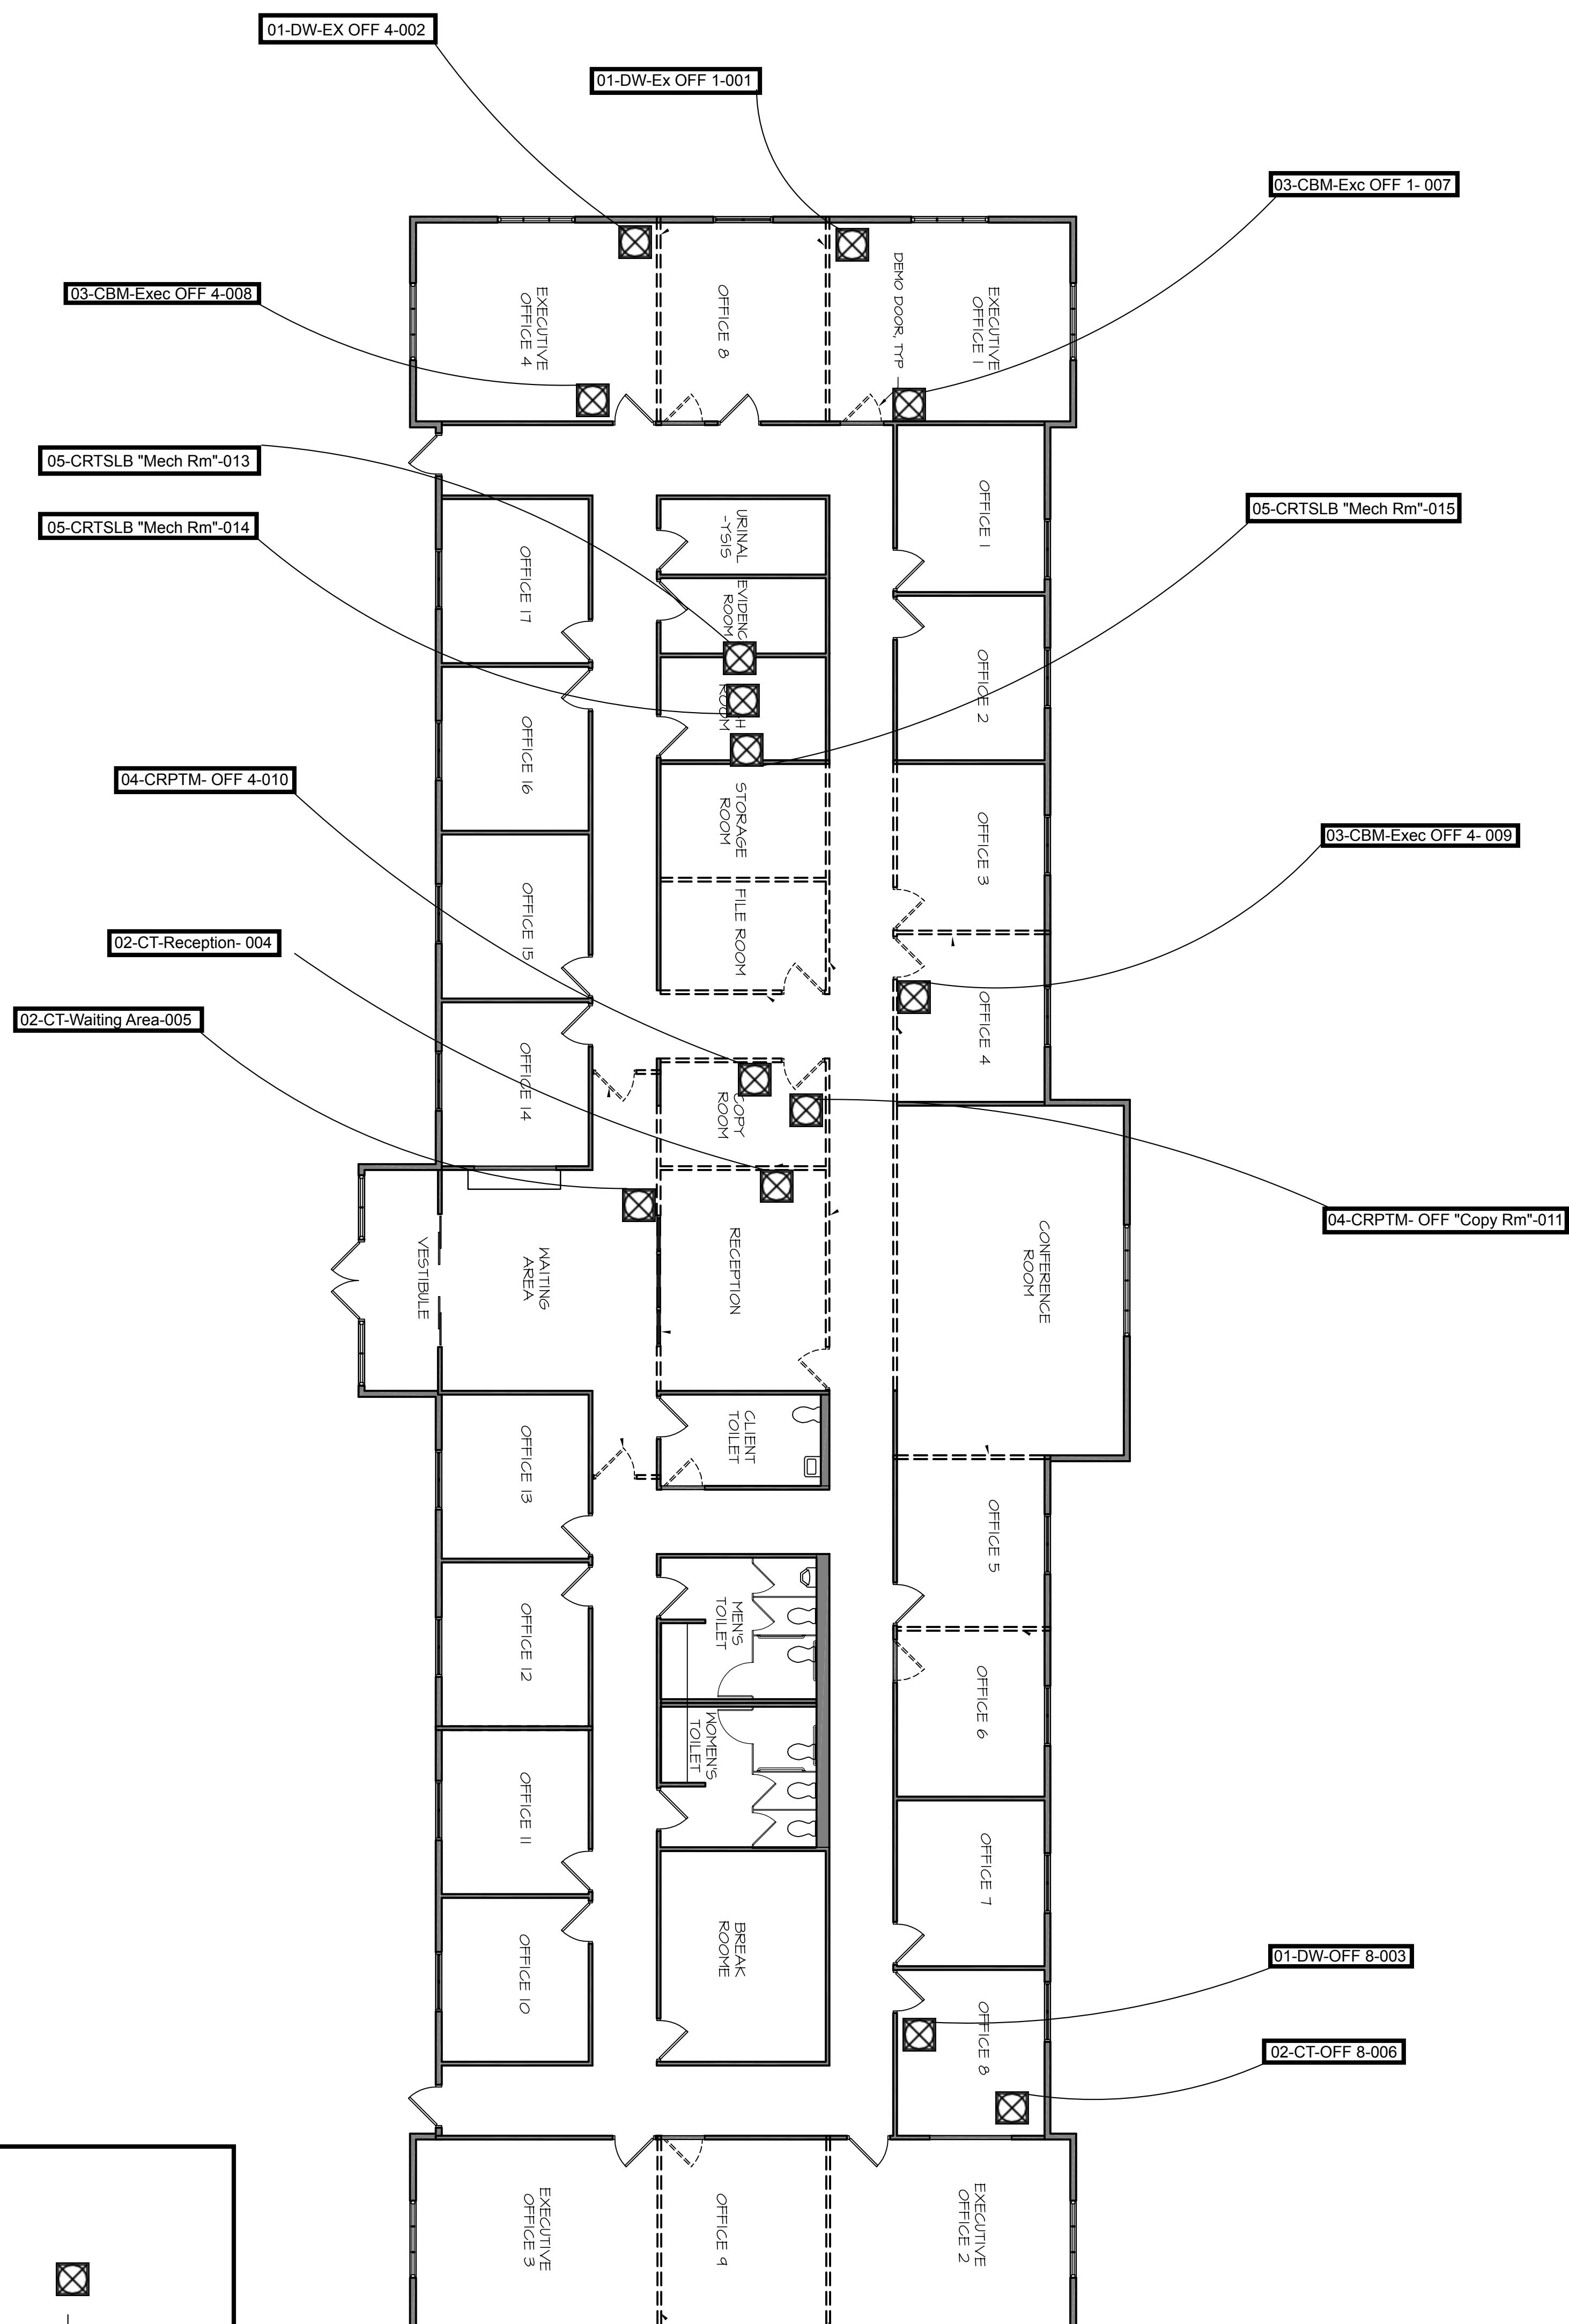
Asbestos Bulk Sample Location Map

☒ — Asbestos Bulk Sample Location

*Note: Approximate Bulk Sample Locations Only
